**ANALYSIS OF ELECTRICAL LOSSES IN MACHINE-TOOLS BY USING  
PREDICTIVE MAINTENANCE THERMOGRAPHY**

This study examines electrical losses in a machine tool workshop using thermography as a predictive maintenance tool. The methodology involved a detailed thermographic inspection of the electrical systems of a compressor, milling machine, and lathe machine, identifying overheating and critical areas during operation. Findings revealed multiple faults, including air leaks, contractor overheating, and faulty electrical connections, all of which contributed to elevated energy consumption. Implementing corrective and preventive measures based on these thermographic insights led to notable energy savings, with estimated reductions of 0.363 kW·h for the milling machine, 0.341 kW·h for the compressor, and 0.322 kW·h for the lathe

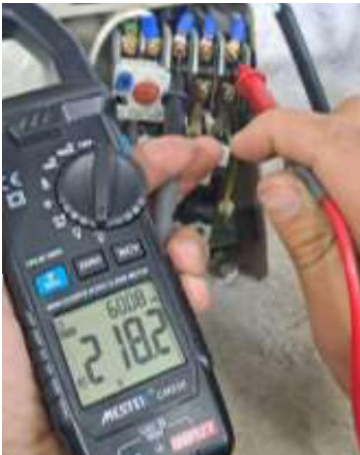
**Figure 1**

Three machines in the workshop have accumulated the most operating hours, suggesting they have been in continuous use for extended periods and may require a thorough review to detect potential electrical and mechanical faults. The first machine is a 5.5 HP double-piston compressor, designed to deliver an airflow of 500 L/min and reach a maximum pressure of 180 psi. This makes it suitable for applications requiring high-pressure compressed air. The compressor is equipped with a three-phase induction motor, operating at a current of 13.9 A and a voltage of 220 V. Its transmission system uses a double pulley to allow for the adjustment of operational speed and torque, optimizing its performance under varying load conditions. A detailed analysis of electrical parameters was conducted, including voltage and current measurements to ensure the equipment is operating within the manufacturer's recommended limits. Voltage readings showed a value close to the nominal, registering 218.2 V from the main distribution board, as shown in Figure 1.

*Measuring compressor motor voltage*

This voltage is appropriate for the motor's operation, indicating a stable power supply. During the air compression process, when the compressor activates to pressurize the system, a current of 13.82 A was measured. This value is slightly lower than the specified value, suggesting that the motor is operating efficiently without significant electrical overload during this cycle. This is important for diagnosing the machine's health, as the amperage within the recommended range reduces the risk of overheating and potential electrical failures that could affect the equipment's durability. These operational data are essential for evaluating the compressor's performance and stability, serving as a reference for implementing predictive maintenance strategies that can prevent failures and extend the lifespan of this critical machine in the workshop.

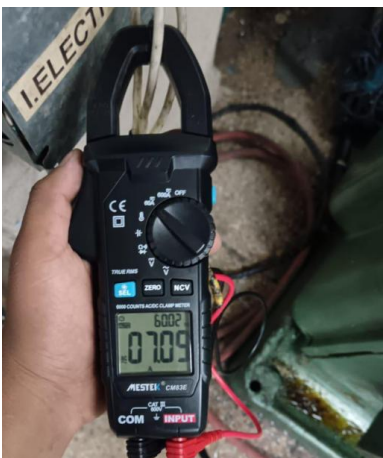
**Figure 4**

During the operation of the milling machine, higher-than-expected electrical consumption was recorded, as shown in Figure 4. A detailed visual inspection revealed several issues with the electrical conductors, including sections of cables lacking proper insulation and improper splicing, compromising the quality of the connection.

*Power consumption of the milling machine in use.*

Additionally, the insulating tape used in the splices was found to be burnt, indicating it could not withstand the operating conditions, contributing to overheating and excessive electricity consumption. These insulation and splicing problems negatively affect the milling machine's energy efficiency, posing a significant risk of electrical failures and potential damage to the equipment.

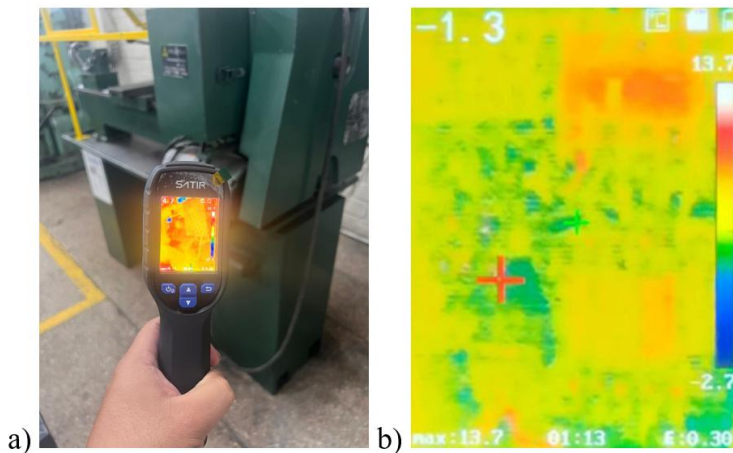
**Figure 5**

The next machine tool to be analyzed is a parallel lathe, equipped with a 2 HP three-phase motor operating at 220 V. Several risks have been identified when operating the lathe under current conditions. One major concern is the motor, which tends to overheat excessively during operation, as shown in Figure 5a. This overheating indicates that the motor is functioning outside its optimal parameters, potentially reducing its lifespan and compromising the safety of both the machine and its operators.

A particularly concerning finding is that, even when the machine is off, the electrical consumption does not drop to an insignificant level, as would be expected. Instead, a current draw of 1.2 A is observed, suggesting a potential current leak or a component that continues to consume power while in idle mode. This electrical loss could be attributed to issues with the motor's disconnect system or wiring problems, which not only increase electrical consumption but also present a risk of overheating or short circuits. Additionally, when inspecting the electrical connections while the lathe is in operation, particularly during machining, an unusual increase in temperature was detected in the electrical panel, as shown in Figure 5b. This temperature rise may indicate poor connections or improper current distribution within the panel, leading to increased resistance and energy loss.

*Analysis of electrical connections on the lathe, a) visual inspection, b) thermography*

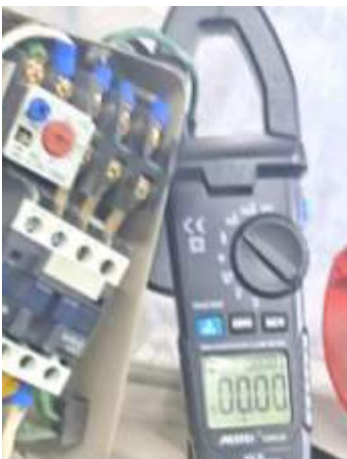
### Figure 6

*Review of zero energy consumption of the compressor in an idle state.*

After reviewing and analyzing the collected data, a comprehensive maintenance plan was developed, incorporating corrective, preventive, and predictive activities aimed at improving electrical energy consumption and ensuring the safe operation of the machines. The plan began with interventions on the compressor, where issues in wiring and contactor connections were identified. Corrective maintenance focused on addressing existing faults affecting the compressor's performance. This involved repairing and replacing defective cables with worn or incomplete insulation, which were causing electrical losses. Additionally, the contactors were readjusted, as they were not closing properly, resulting in small current leaks. Precise adjustments ensured a firm and stable connection.

Loose connections were also found, increasing resistance and causing overheating. These were tightened to improve the current flow. These corrective interventions led to an immediate reduction in electricity consumption when the compressor was off, eliminating energy leaks and improving operational safety, as shown in Figure 6. Preventive maintenance, on the other hand, was designed to reduce the risk of future failures and improve energy consumption

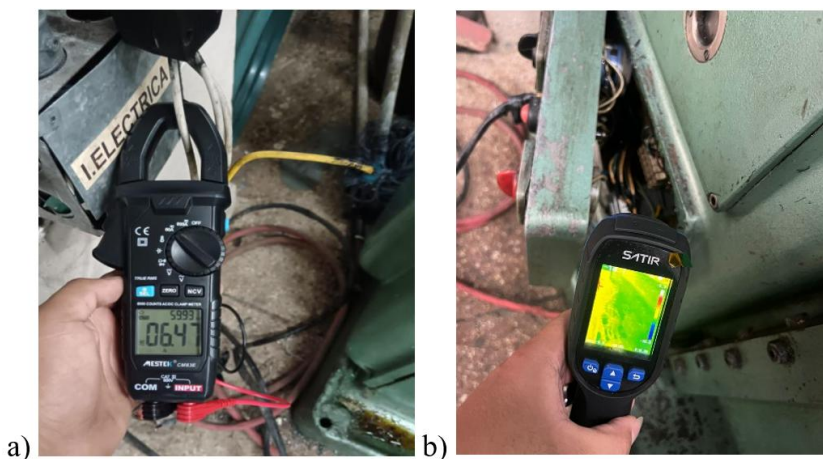
**Figure 9**

A thermographic camera was used to verify these improvements, with Figure 9b displaying the thermographic analysis results. The analysis confirmed that the previously observed hot spots, which indicated areas of overheating, were no longer present. This visual confirmation underscores that issues related to overheating and energy loss were effectively resolved, contributing to a safer and more efficient operation of the equipment. These corrective measures are estimated to achieve energy savings of 0.363 kW·h, enhancing the milling machine's operational efficiency and yielding direct benefits in reduced operational costs and environmental impact.

*Maintenance activities on the milling machine, a) correct amperage measurement, b) thermography*

For the milling machine, targeted corrective actions were implemented to resolve previously identified electrical issues. The defective contactor, which had been causing overheating and unnecessary power consumption, was replaced. Additionally, conductor routing was reorganized to ensure proper channeling and protection. Following these adjustments, electrical consumption for the milling machine dropped from 7.1 A to 6.47 A, aligning more closely with the manufacturer's recommended maximum, as depicted in Figure 9a. This amperage reduction demonstrates that the improvements had a positive impact on the machine's energy efficiency, performance, and prevented excessive power use.

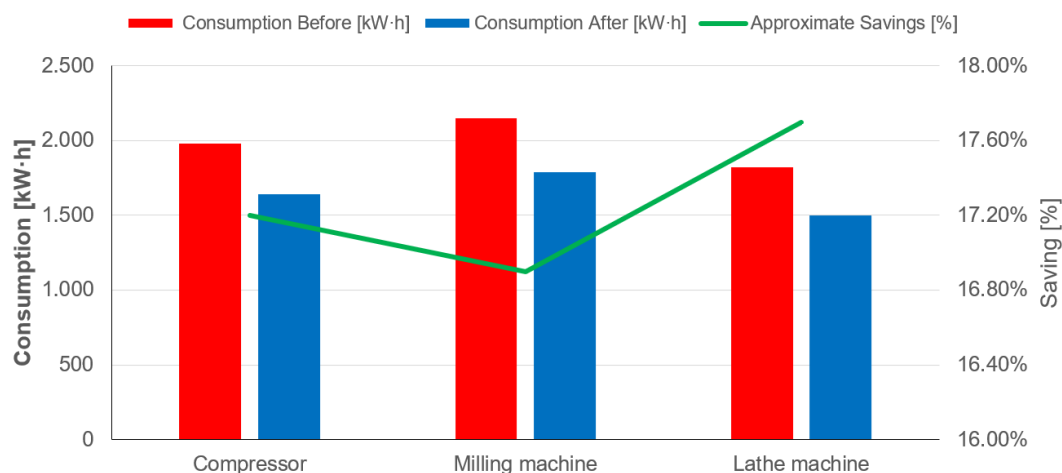
**Figure 11**

The study focused on three main machines, starting with a compressor that showed significant air leaks and inefficient operation, leading to unnecessary energy use, particularly while the compressor was off. Figure 11 illustrates how energy consumption changed after applying predictive maintenance based on thermographic inspections to three machine tools: a compressor, a milling machine, and a lathe. After addressing issues like overheating, air leaks, and poor electrical connections, a noticeable drop in power usage was observed, highlighting the practical benefits of using thermography to detect and resolve energy-related faults in industrial equipment. Electrical connections on a universal milling machine were also evaluated, where overheating in the contactor due to faulty wiring was detected. By replacing the contactor and organizing the conductors, energy savings of approximately 0.363 kW·h were achieved. Finally, an analysis of a parallel lathe identified a 9 % overcurrent factor, which was increasing energy consumption. Replacing the defective contactor and performing a thermographic inspection eliminated overheating and reduced power usage by 0.322 kW·h.

*Electric consumption*
